Navajo Abandoned Uranium Mine

Site Screen Report

Mine Name: Fern No. 1
Mine ID: 257

Weston Solutions, Inc.

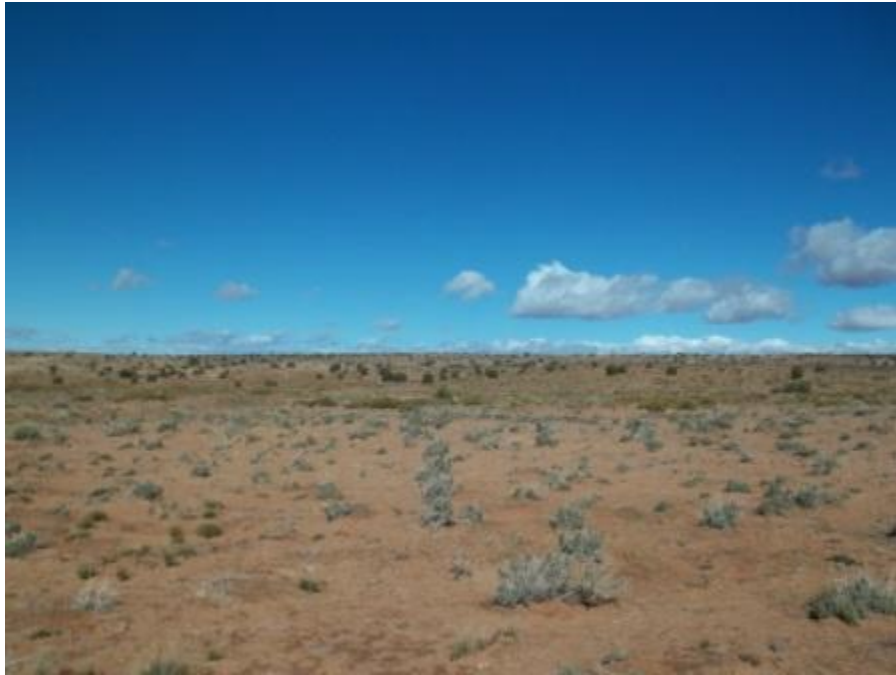
Photo 1

Mine Site #257
